## Palau Biomedical Support contributes to Financial Savings for the Ministry of Health

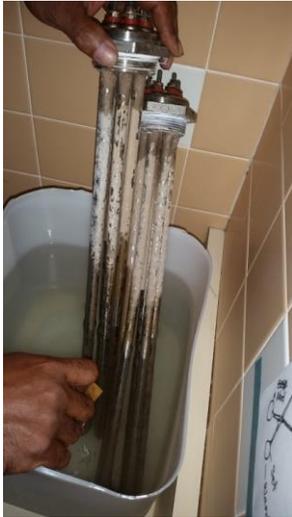
*Photo 1 – Dirty scaled rods*

The biomedical technicians, Mr Eric Rechucher and Mr Alben Adelbai found the heating elements and chamber covered with scales, worn out check valves and steam traps, which had increased the time for the autoclave to reach its operating temperature, prevented the load from drying up at the end of the cycle, and eventually failing and flooding the CSSD area.

Apart from irregular maintenance, one of the major factors that had contributed towards the scaling of the elements and chamber, and failure of the unit was use of chlorinated water i.e. water that was not deionized or softened. To resolve this issue, the biomedical technicians are working with superiors to either have functional water treatment system for the entire facility or provide necessary medium for the autoclave water line.

The technicians soaked the heating elements in concentrated citric acid for several days, cleaned the chamber and replaced necessary worn out parts. The autoclave was repaired just in time for Palau to host a number of visiting specialist teams. The repaired autoclave, as they say, "is now as good as new". In comparison to a US\$ 35,000 new autoclave, the Ministry of Health spent only US\$ 2,500 for parts and avoided the long wait of receiving a new autoclave.

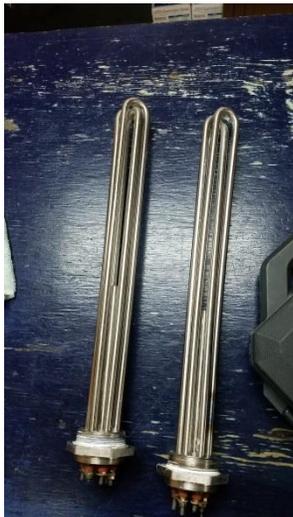
*Photo 2 – Clean shiny rods*
